**Flood Control Project Maintenance
Levee Inspections**
LMA District Cover Sheet
Spring 2018 Levee Inspection Results

Reclamation District No. 0563 Tyler Island

Spring 2018 Levee Inspection Results

Waterway			Bank	Unit Miles
Unit No. 01 Georgiana Slough (Tyler Island)			Left	12.11
	Spring (March - May)	Summer (June - August)	(September - November) Fall	Winter (December - February)
Unit Maintenance Rating (Fall Only)				
Date of Inspection	3/30/2018 - 3/30/2018			
DWR Inspector	Keith Millard			
Accompanied By	Steve Mello RD 563

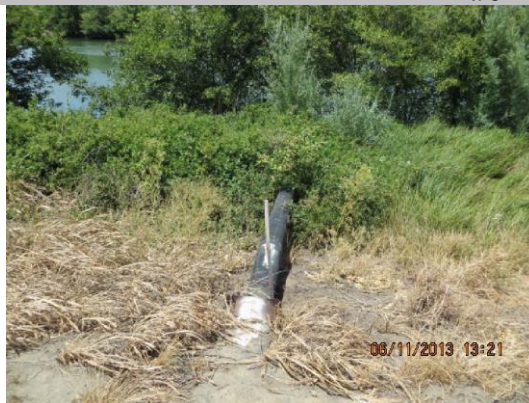
Photo 1 of 3 : UCIP_SP_2018_14963_24622.jpg

FS_ID:14963
DS_ID:20150
EP_NO: 11200
Repair Type: Non-Urgent
Crossing Status: Found
UCIP Comments: No permit identified for 10-inch irrigation pipe that is sleeved through the 18-inch.
FIELD_STRUCT_DESC: 18-inch steel irrigation pipe through the levee, 5.2 feet below the crown. 10-inch steel irrigation siphon sleeved through the 18-inch pipe. Siphon breaker in a 24-inch corrugated metal pipe (CMP) riser on the landside (LS) shoulder. Air vent on pipe on the LS slope. Slide gate at booster/filter plant off the LS toe. (Automatic Board Order (ABO) issued as Permit No. 11200, 1975 - Cora R. and Furth Brandt). [Additional Reference(s): DWR Levee Log, 2005. USACE Sacramento O&M Manual 103, June 1954, (Station "L" 321+03) pipe is plugged].
FS Date: 6/11/2013

10-inch pipe sleeved through 18-inch conduit.

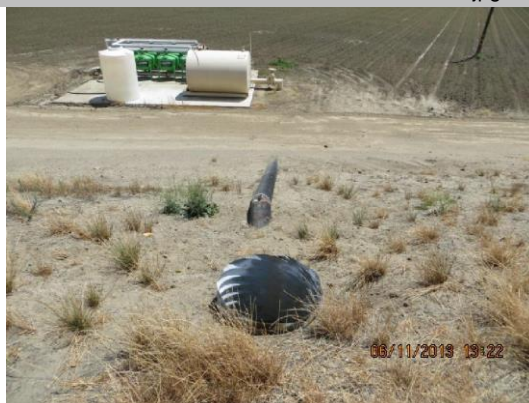
Photo 2 of 3 : UCIP_SP_2018_14963_24621.jpg

Siphon breaker in 24-inch CMP riser on LS shoulder.

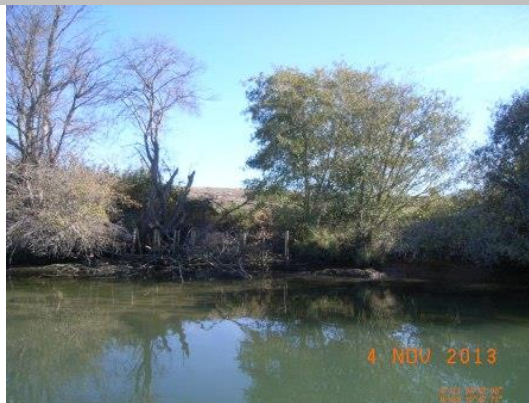
Photo 1 of 1 : SP_2018_RD0563_210_44_20180305_00032.jpg

LM Start	6.38	Rating **	M	Issue No.	44
LM End	6.46	Issue Type +	Ma	Location *	WS
Category	Supplemental			GPS Latitude/Longitude	
				Start	End
Item	2015 USACE Erosion Survey, DRAFT			38.180462 °	38.179319 °
				-121.577895 °	-121.578566 °
DWR ID	DWR_RD0563_01_s_2016_44				
Comment Code					
Inspector Comment					
2013 - Erosion pockets into the levee prism. Erosion pockets primarily located behind unmaintained brush boxes. 2015: Last observed in 2013. [2015 Site ID: GEO_5-8_L]

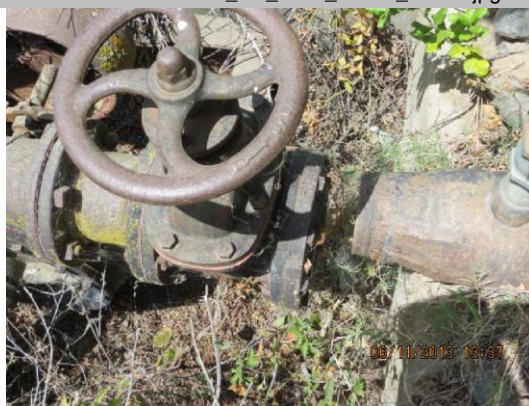
Photo 1 of 3 : UCIP_SP_2018_14966_24628.jpg

LM Start	6.57	Rating **	M	Issue No.	791
LM End	6.57	Issue Type +	En	Location *	
Category	Supplemental			GPS Latitude/Longitude	
				Start	End
Item	DWR UCIP Field Study			38.177779 °	38.177779 °
				-121.578995 °	-121.578995 °
DWR ID					
Comment Code					
Inspector Comment					
FS_ID:14966 DS_ID:20152 EP_NO: 11201 Repair Type: Non-Urgent Crossing Status: Found UCIP Comments: Appears abandoned and should be done so properly. FIELD_STRUCT_DESC: 3 of 3: 8-inch steel irrigation pipe through the levee, 4.7 feet below the crown. Pump and gate valve on the waterside (WS) berm. 4-foot-diameter concrete standpipe on the landside (LS) toe. Y-ramp on the WS slope. (Automatic Board Order (ABO) issued as Permit No. 11201, 1975 - Joseph Brun). [Additional Reference(s): DWR Levee Log, 2005. USACE Sacramento O&M Manual 103, June 1954, (Station ""L "" 294+25.1)]. FS Date: 6/11/2013

No connection to pump on WS shoulder.

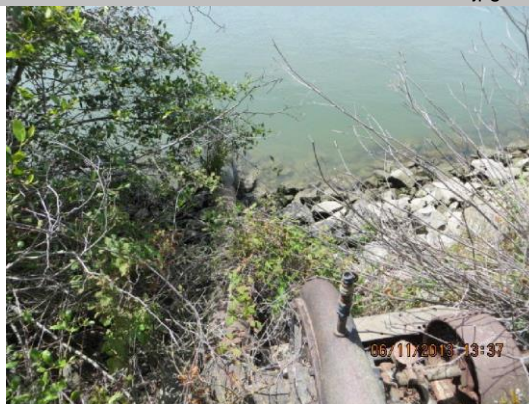
Photo 2 of 3 : UCIP_SP_2018_14966_24627.jpg

Pump and pipe on WS slope.

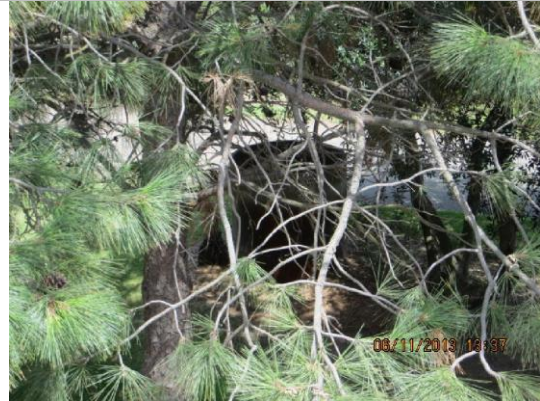
Photo 3 of 3 : UCIP_SP_2018_14966_24630.jpg

LM Start	6.57	Rating **	M	Issue No.	791 (cont)
LM End	6.57	Issue Type +	En	Location *	
Category	Supplemental			GPS Latitude/Longitude	
				Start	End
Item	DWR UCIP Field Study			38.177779 °	38.177779 °
				-121.578995 °	-121.578995 °
DWR ID					
Comment Code					
Inspector Comment					
FS_ID:14966 DS_ID:20152 EP_NO: 11201 Repair Type: Non-Urgent Crossing Status: Found UCIP Comments: Appears abandoned and should be done so properly. FIELD_STRUCT_DESC: 3 of 3: 8-inch steel irrigation pipe through the levee, 4.7 feet below the crown. Pump and gate valve on the waterside (WS) berm. 4-foot-diameter concrete standpipe on the landside (LS) toe. Y-ramp on the WS slope. (Automatic Board Order (ABO) issued as Permit No. 11201, 1975 - Joseph Brun). [Additional Reference(s): DWR Levee Log, 2005. USACE Sacramento O&M Manual 103, June 1954, (Station ""L "" 294+25.1)]. FS Date: 6/11/2013

4-foot concrete standpipe on LS toe.

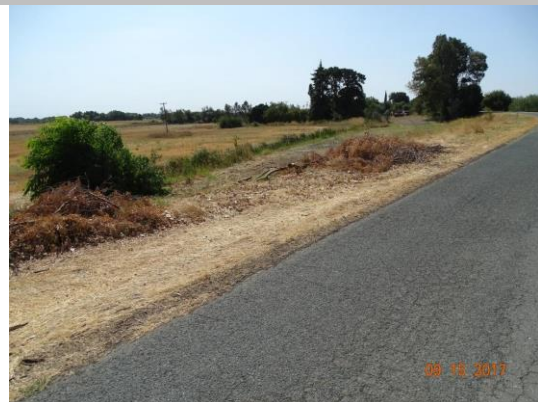
Photo 1 of 1 : SP_2018_RD0563_210_128_20180305_00109.jpg

LM Start	6.67	Rating **	M	Issue No.	128
LM End	6.67	Issue Type +	En	Location *	LS
Category	Earthen Levee			GPS Latitude/Longitude	
				Start	End
Item	Encroachments			38.176387 °	38.176387 °
				-121.579670 °	-121.579670 °
DWR ID	DWR_RD0563_01_s_2017_128				
Comment Code					
PR : Prunings					
Inspector Comment					
Broken tree branches and limbs on landside slope.

Looking south at the landside slope.

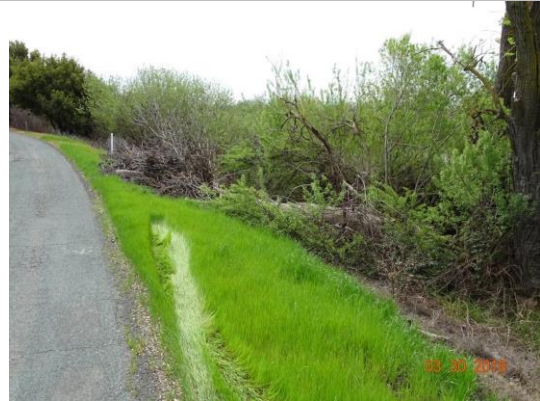
Photo 1 of 1 : SP_2018_RD0563_210_93_20180330_00244.jpg

LM Start	6.74	Rating **	U	Issue No.	93
LM End	6.74	Issue Type +	Ma	Location *	WS
Category	Earthen Levee			GPS Latitude/Longitude	
				Start	End
Item	Encroachments			38.175352 °	38.175352 °
				-121.580177 °	-121.580177 °
DWR ID	DWR_RD0563_01_s_2018_93				
Comment Code					
TR : Tree or limb					
Inspector Comment					
Large fallen tree should be removed from waterside slope and shoulder.

Remove fallen tree from levee slope.

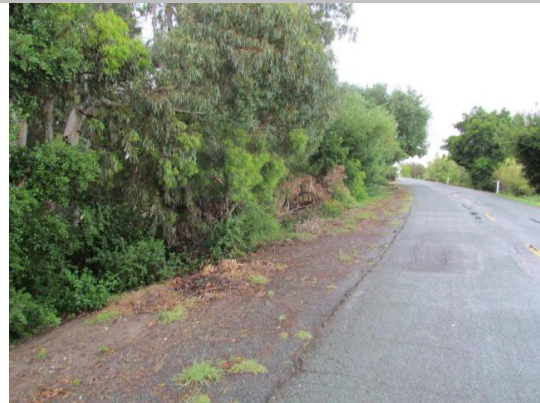
Photo 1 of 1 : SP_2018_RD0563_210_145_20180305_00122.jpg

LM Start	6.75	Rating **	U	Issue No.	145
LM End	6.79	Issue Type +	En	Location *	LS
Category	Earthen Levee			GPS Latitude/Longitude	
				Start	End
Item	Vegetation			38.175219 °	38.174743 °
				-121.580053 °	-121.580016 °
DWR ID	DWR_RD0563_01_s_2014_145				
Comment Code					
V6 : Landscaping					
Inspector Comment					
Untrimmed trees blocking view of landside toe.

Looking southeast at dense vegetation on landward slope and toe.

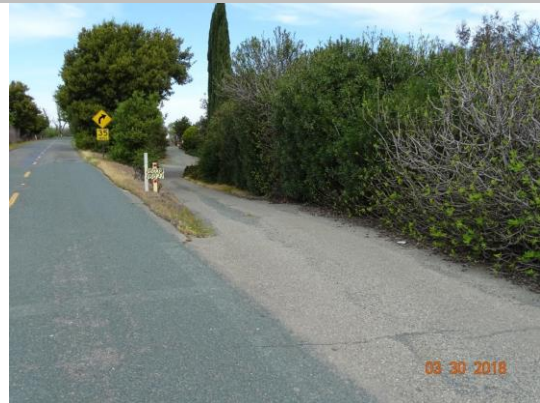
Photo 1 of 1 : SP_2018_RD0563_210_119_20180330_00242.jpg

LM Start	6.84	Rating **	U	Issue No.	119
LM End	6.87	Issue Type +	En	Location *	LS
Category	Earthen Levee			GPS Latitude/Longitude	
				Start	End
Item	Vegetation			38.173912 °	38.173523 °
				-121.579838 °	-121.579737 °
DWR ID	DWR_RD0563_01_s_2018_119				
Comment Code					
V6 : Landscaping					
Inspector Comment					
Thick landscaping prohibits inspection and access.

Thick landside landscaping preventing inspection and access.

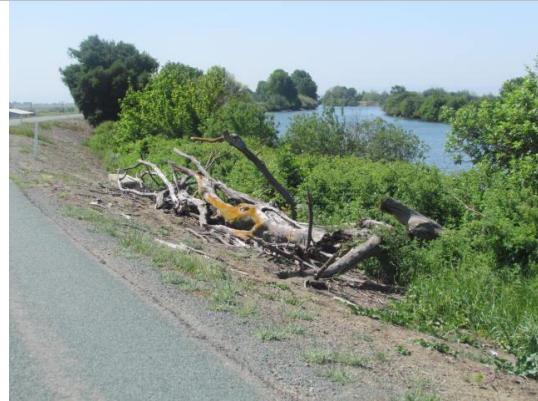
Photo 1 of 1 : SP_2018_RD0563_210_95_20180305_00081.jpg

LM Start	6.95	Rating **	M	Issue No.	95
LM End	6.95	Issue Type +	Ma	Location *	WS
Category	Earthen Levee			GPS Latitude/Longitude	
				Start	End
Item	Encroachments			38.172351 °	38.172351 °
				-121.579520 °	-121.579520 °
DWR ID	DWR_RD0563_01_f_2012_95				
Comment Code					
TR : Tree or limb					
Inspector Comment					
Fallen tree should be removed from waterside slope.

Looking southwest at prunings on waterward slope.

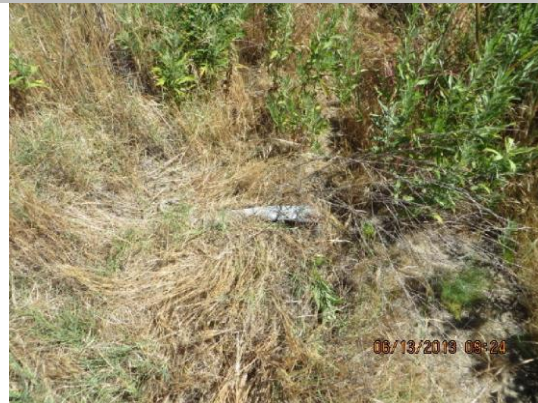
Photo 1 of 3 : UCIP_SP_2018_14968_24637.jpg

Comment Code						
Inspector Comment						
FS_ID:14968 DS_ID:20154 EP_NO: 11214 Repair Type: Non-Urgent Crossing Status: Indicator Found UCIP Comments: Verify type of abandonment. Wide berm on LS toe with some evidence of steel slide gate in soil at berm. FIELD_STRUCT_DESC: 1 of 2: 8-inch steel irrigation pipe through the levee, 3.7 feet below the crown. Siphon breaker on the waterside (WS) slope. (Automatic Board Order (ABO) issued as Permit No. 11214, 1975 - River Island Land Company). [Additional Reference(s): DWR Levee Log, 2005. USACE Sacramento O&M Manual 103, June 1954, (Station ""L"" 269+36) 1-inch air and primer valve, reinforced concrete spillbox]. FS Date: 6/13/2013

Steel parts on LS toe may indicate location of distribution box.

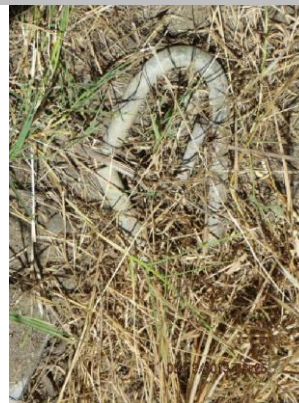
Photo 2 of 3 : UCIP_SP_2018_14968_24636.jpg

Comment Code						
Inspector Comment						
FS_ID:14968 DS_ID:20154 EP_NO: 11214 Repair Type: Non-Urgent Crossing Status: Indicator Found UCIP Comments: Verify type of abandonment. Wide berm on LS toe with some evidence of steel slide gate in soil at berm. FIELD_STRUCT_DESC: 1 of 2: 8-inch steel irrigation pipe through the levee, 3.7 feet below the crown. Siphon breaker on the waterside (WS) slope. (Automatic Board Order (ABO) issued as Permit No. 11214, 1975 - River Island Land Company). [Additional Reference(s): DWR Levee Log, 2005. USACE Sacramento O&M Manual 103, June 1954, (Station ""L"" 269+36) 1-inch air and primer valve, reinforced concrete spillbox]. FS Date: 6/13/2013

Steel parts on LS toe may indicate location of distribution box.

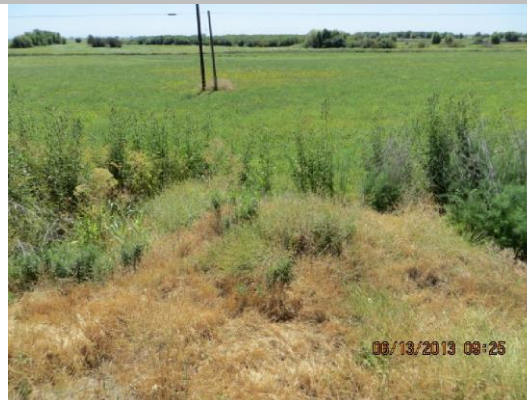
Photo 3 of 3 : UCIP_SP_2018_14968_24635.jpg

Wide berm on LS toe.

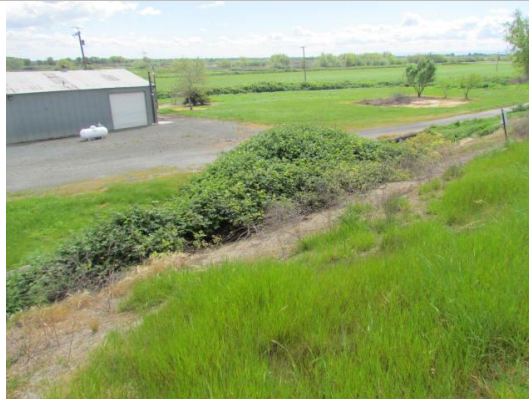
Photo 1 of 1 : SP_2018_RD0563_210_151_20180305_00126.jpg

LM Start	7.07	Rating **	U	Issue No.	151
LM End	7.07	Issue Type +	Ma	Location *	LS
Category	Earthen Levee			GPS Latitude/Longitude	
				Start	End
Item	Vegetation			38.170693 °	38.170693 °
				-121.579968 °	-121.579968 °
DWR ID	DWR_RD0563_01_f_2014_151				
Comment Code					
V2 : Remove the wild growth other than native grasses from the levee slopes.					
Inspector Comment					
Dense berryvines at landside toe.

Looking southeast at dense vegetation at landward toe.

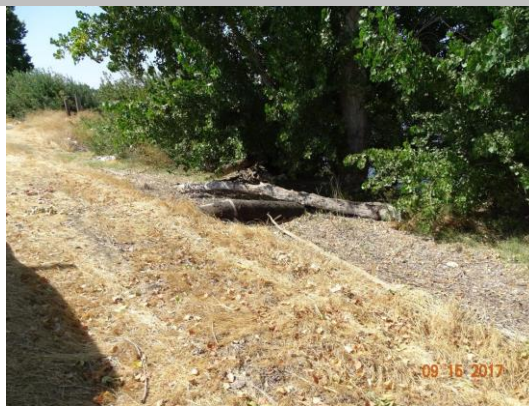
Photo 1 of 1 : SP_2018_RD0563_210_117_20180305_00097.jpg

LM Start	7.36	Rating **	M	Issue No.	117
LM End	7.36	Issue Type +	Ma	Location *	WS
Category	Earthen Levee			GPS Latitude/Longitude	
				Start	End
Item	Encroachments			38.166856 °	38.166856 °
				-121.582091 °	-121.582091 °
DWR ID	DWR_RD0563_01_f_2017_117				
Comment Code					
TR : Tree or limb					
Inspector Comment

Looking southwest at the waterside slope.

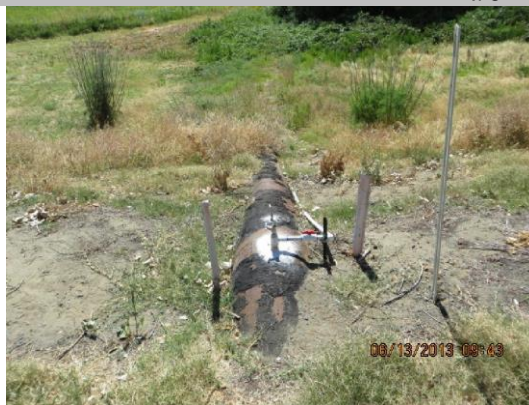
Photo 2 of 2 : UCIP_SP_2018_42743_24640.jpg

Pipe, vent, and filler valve on LS shoulder.

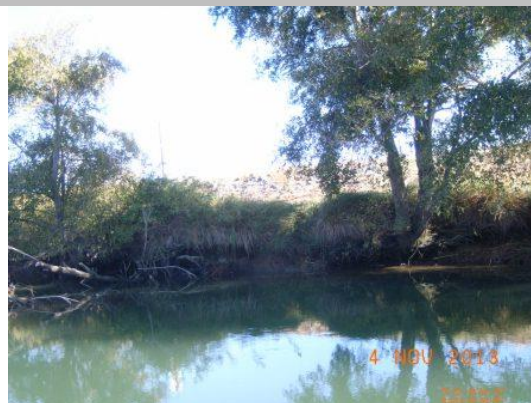
Photo 1 of 1 : SP_2018_RD0563_210_53_20180305_00039.jpg

LM Start	7.53	Rating **	U	Issue No.	53
LM End	7.80	Issue Type +	Ma	Location *	WS
Category	Supplemental			GPS Latitude/Longitude	
				Start	End
Item	2015 USACE Erosion Survey, DRAFT			38.164462 °	38.160888 °
				-121.583092 °	-121.584807 °
DWR ID	DWR_RD0563_01_s_2016_53				
Comment Code					
Inspector Comment					
1997 - Pocket erosion at upstream end and into the levee toe under the Alder trees. 2003 - New brush boxes with wattles on bank. 2004 - No brush boxes. 2005 - Site extended from the downstream side of the bridge. Whole bank is vertical. 2010 - Some minor new erosion. 2011 - Site upgraded to CRITICAL. New erosion pockets throughout the site. Sites 4.5, and 4.6 were combined. 2015: Last observed in 2013. [2015 Site ID: GEO_4-5_L]

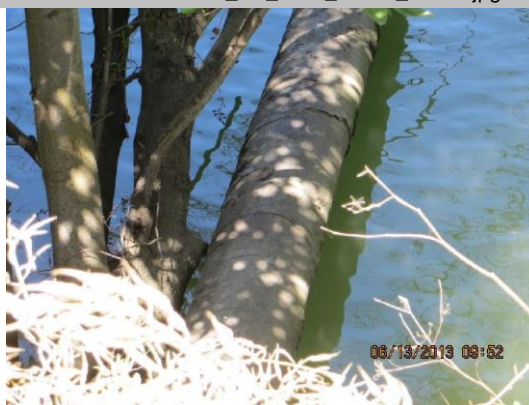
Photo 1 of 2 : UCIP_SP_2018_16304_27464.jpg

LM Start	7.72	Rating **	M	Issue No.	795
LM End	7.72	Issue Type +	En	Location *	
Category	Supplemental			GPS Latitude/Longitude	
				Start	End
Item	DWR UCIP Field Study			38.161873 °	38.161873 °
				-121.584109 °	-121.584109 °
DWR ID					
Comment Code					
Inspector Comment					
FS_ID:16304					
DS_ID:20185					
EP_NO: N/A					
Repair Type: Non-Urgent					
Crossing Status: Found					
UCIP Comments: Slight depression in crown along pipe alignment may be indication of pipe internal failure. Good candidate for video inspection.					
FIELD_STRUCT_DESC: 14-inch steel irrigation pipe through the levee, 5.1 feet below the crown. [Additional Reference(s): USACE Sacramento O&M Manual 103, June 1954, (Station ""L"" 233+50.5)].					
FS Date: 6/13/2013

Pipe visible on WS toe.

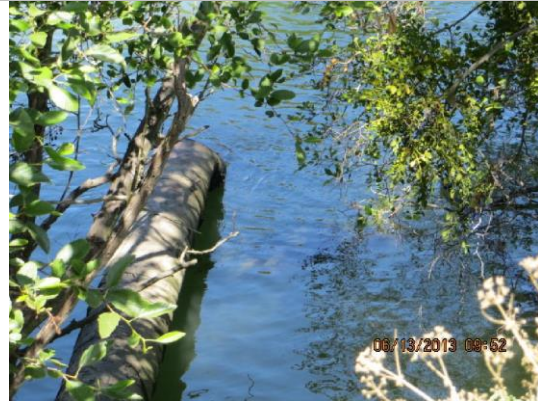
Photo 2 of 2 : UCIP_SP_2018_16304_27463.jpg

LM Start	7.72	Rating **	M	Issue No.	795 (cont)	
LM End	7.72	Issue Type +	En	Location *		
Category	Supplemental			GPS Latitude/Longitude		
				Start	End	
Item	DWR UCIP Field Study			38.161873 °	38.161873 °	
				-121.584109 °	-121.584109 °	
DWR ID						
Comment Code						
Inspector Comment						
FS_ID:16304						
DS_ID:20185						
EP_NO: N/A						
Repair Type: Non-Urgent						
Crossing Status: Found						
UCIP Comments: Slight depression in crown along pipe alignment may be indication of pipe internal failure. Good candidate for video inspection.						
FIELD_STRUCT_DESC: 14-inch steel irrigation pipe through the levee, 5.1 feet below the crown. [Additional Reference(s): USACE Sacramento O&M Manual 103, June 1954, (Station ""L"" 233+50.5)].						
FS Date: 6/13/2013

Pipe visible on WS toe.

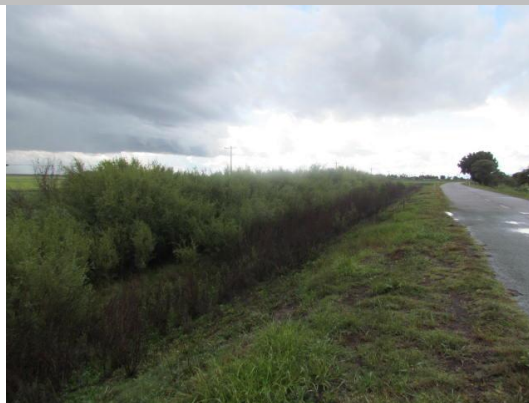
Photo 1 of 5 : SP_2018_RD0563_210_90_20180305_00075.jpg

Looking southeast at dense vegetation at landward toe. (Spring 2015)

LM Start	7.80	Rating **	U	Issue No.	90 (cont)	
LM End	7.94	Issue Type +	Ma	Location *	LS	
Category	Earthen Levee			GPS Latitude/Longitude		
				Start	End	
Item	Vegetation			38.160800 °	38.158922 °	
				-121.584598 °	-121.585433 °	
DWR ID	DWR_RD0563_01_s_2012_90					
Comment Code						
V2 : Remove the wild growth other than native grasses from the levee slopes.						
Inspector Comment						
Berryvines and willows on landside toe.

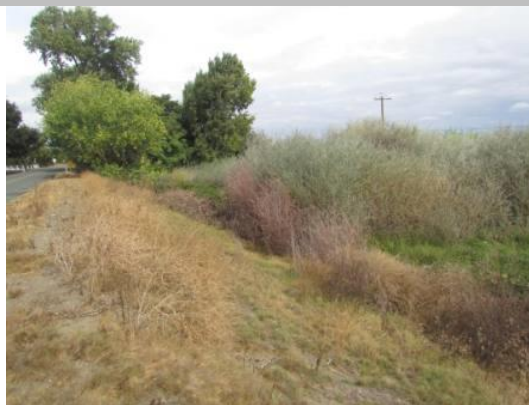
Photo 2 of 5 : SP_2018_RD0563_210_90_20180305_00076.jpg

Looking northeast at dense vegetation on landside toe.

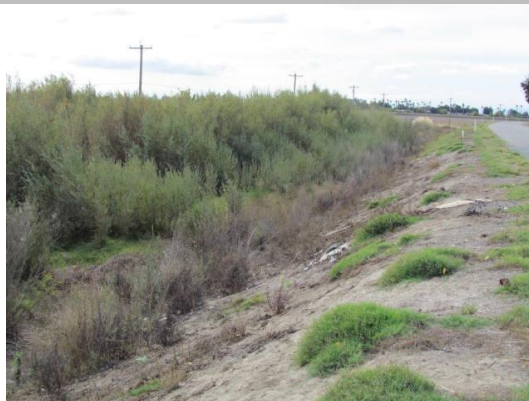
Photo 3 of 5 : SP_2018_RD0563_210_90_20180305_00077.jpg

Looking south at dense vegetation on landside toe. (2012 Fall Inspection)

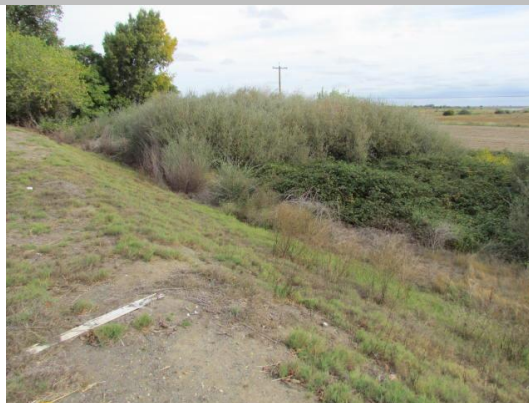
Photo 4 of 5 : SP_2018_RD0563_210_90_20180305_00078.jpg

Looking northeast at dense vegetation on landside toe. (2012 Fall Inspection)

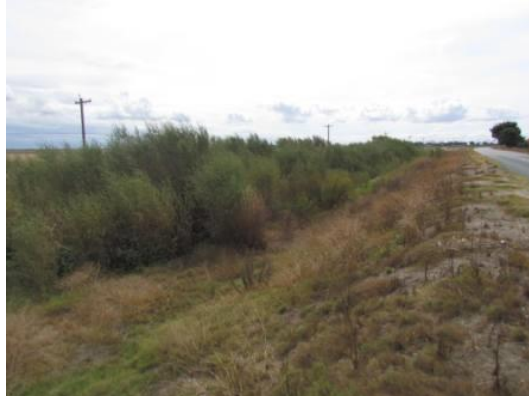
Photo 5 of 5 : SP_2018_RD0563_210_90_20180305_00079.jpg

Looking southwest at dense vegetation on landside toe.

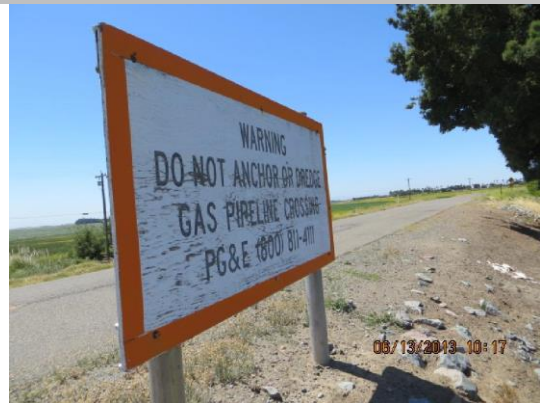
Photo 1 of 2 : UCIP_SP_2018_16265_27407.jpg

LM Start	7.92	Rating **	M	Issue No.	797	
LM End	7.92	Issue Type +	En	Location *		
Category	Supplemental			GPS Latitude/Longitude		
				Start	End	
Item	DWR UCIP Field Study			38.159148 °	38.159148 °	
				-121.585329 °	-121.585329 °	
DWR ID						
Comment Code						
Inspector Comment						
FS_ID:16265 DS_ID:23974 EP_NO: N/A Repair Type: Non-Urgent Crossing Status: Found UCIP Comments: Need to determine disposition of all gaslines in this immediate area. FIELD_STRUCT_DESC: Gas line of an unknown size or material through the levee, at an unknown depth. Gas line marker on the WS shoulder. FS Date: 6/13/2013

Sign on WS shoulder.

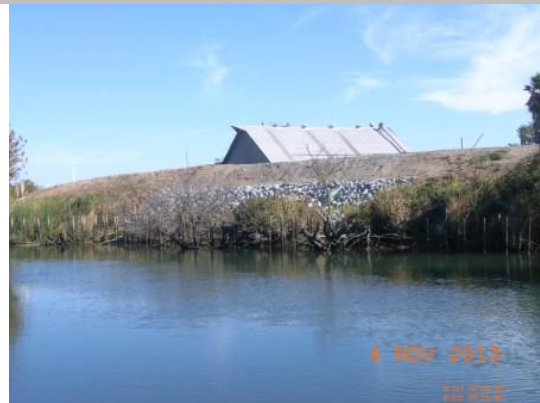
Photo 1 of 1 : SP_2018_RD0563_210_40_20180305_00028.jpg

Comment Code					
Inspector Comment					
1997 - Pockets of erosion into the levee at the water line. Alders are being undercut and rotating out into the channel. Damaged rock at upstream end. 2000 - New minor erosion. 2001 - Staked low fascine walls at bankline. 2002 - New "Brush Boxes" along the bank toe. 2003 - New erosion pockets in the middle of the site. 2005 - Some new bundles in the brush boxes. 2011 - Site upgraded to CRITICAL. Significant new erosion. Sites 3.6, 3.7, 3.71, and 4.0 were combined. 2012 - Rock has been placed in some of the erosion pockets since last year, however site remains critical. 2013 - Site no longer critical. The worst pockets were filled with rock by the local RD. 2015: Last observed in 2013. [2015 Site ID: GEO_3-8_L]

USACE 2013 Photo #1

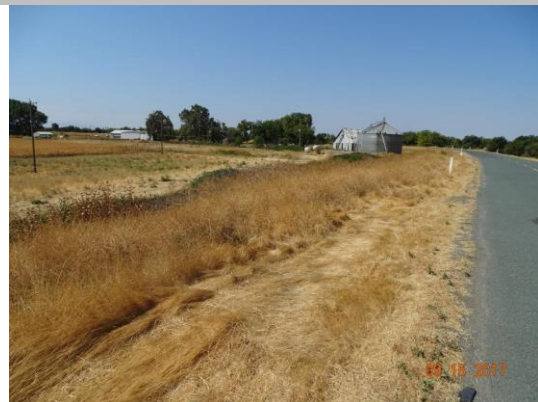
Photo 1 of 3 : SP_2018_RD0563_210_767_20180305_00138.jpg

LM Start	8.18	Rating **	U	Issue No.	767
LM End	8.22	Issue Type +	Ma	Location *	LS
Category	Earthen Levee			GPS Latitude/Longitude	
				Start	End
Item	Vegetation			38.156878 °	38.156945 °
				-121.588505 °	-121.589258 °
DWR ID	DWR_RD0563_01_s_2015_767				
Comment Code					
V2 : Remove the wild growth other than native grasses from the levee slopes.					
Inspector Comment					
Dead dense vegetation blocking landside toe.

Looking south at the landside slope.

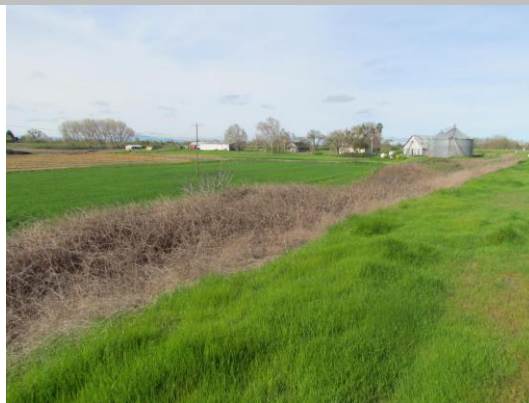
Photo 2 of 3 : SP_2018_RD0563_210_767_20180305_00139.jpg

LM Start	8.18	Rating **	U	Issue No.	767 (cont)	
LM End	8.22	Issue Type +	Ma	Location *	LS	
Category	Earthen Levee			GPS Latitude/Longitude		
				Start		End
Item	Vegetation			38.156878 °		38.156945 °
				-121.588505 °		-121.589258 °
DWR ID	DWR_RD0563_01_s_2015_767					
Comment Code						
V2 : Remove the wild growth other than native grasses from the levee slopes.						
Inspector Comment						
Dead dense vegetation blocking landside toe.

Looking south at dead vines at landward toe. (Spring 2017)

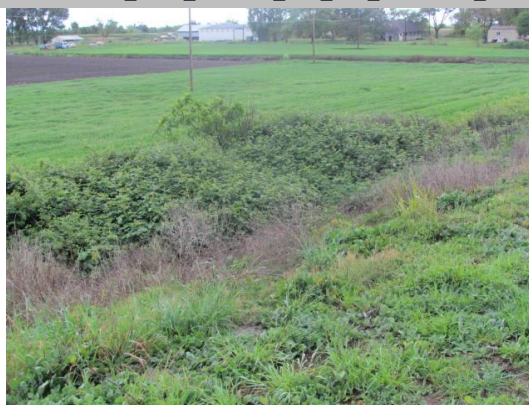
Photo 3 of 3 : SP_2018_RD0563_210_767_20180305_00140.jpg

Looking south at dense wild vines at landward toe. (Fall 2016)

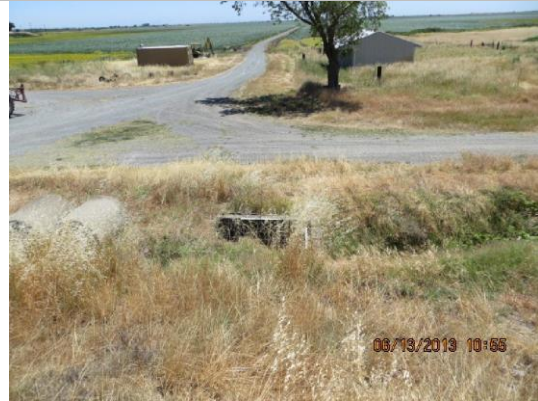
Photo 3 of 3 : UCIP_SP_2018_14990_24675.jpg

Comment Code						
Inspector Comment						
FS_ID:14990 DS_ID:20161 EP_NO: 11217 Repair Type: Non-Urgent Crossing Status: Found UCIP Comments: Pipe appears abandoned and should be done so properly. FIELD_STRUCT_DESC: 1 of 11: 12-inch steel irrigation siphon pipe through the levee, 3.6 feet below the crown. Vent/filler pipe on the landside (LS) shoulder, and a slide gate in a 7-foot by 9-foot concrete distribution box on the LS toe. (Automatic Board Order (ABO) issued as Permit No. 11217, 1975 - Owen E. Wilkenson). [Additional Reference(s): DWR Levee Log, 2005. USACE Sacramento O&M Manual 103, June 1954, (Station ""L "" 193+23.5)]. FS Date: 6/13/2013

7'X9' concrete distribution box on LS toe.

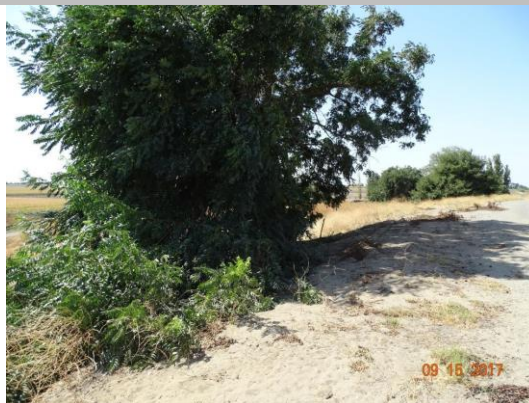
Photo 1 of 2 : SP_2018_RD0563_210_768_20180305_00141.jpg

LM Start	9.25	Rating **	M	Issue No.	768
LM End	9.25	Issue Type +	Ma	Location *	LS
Category	Earthen Levee			GPS Latitude/Longitude	
				Start	End
Item	Trim / Thin Trees			38.145897 °	38.145897 °
				-121.588203 °	-121.588203 °
DWR ID	DWR_RD0563_01_s_2015_768				
Comment Code					
T1 : Trim trees to at least five feet above ground level.					
Inspector Comment

Looking south at the landside slope.

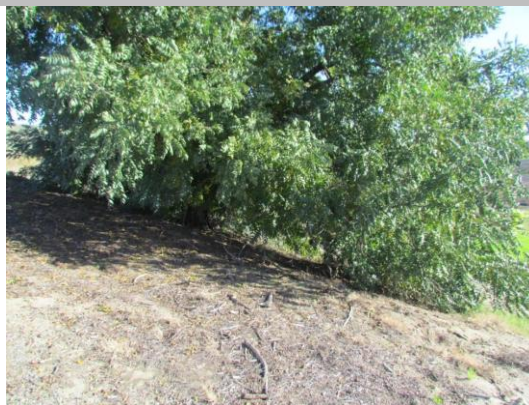
Photo 2 of 2 : SP_2018_RD0563_210_768_20180305_00142.jpg

Looking at untrimmed tree on landward slope.

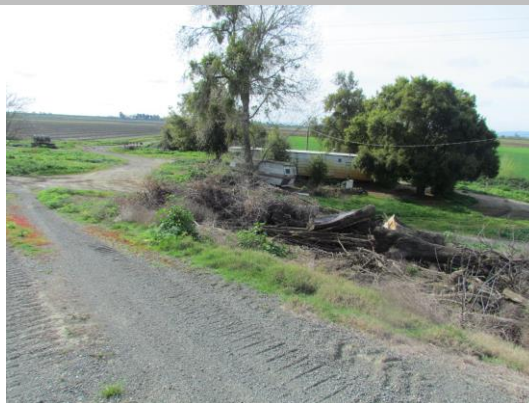
Photo 1 of 3 : SP_2018_RD0563_210_73_20180305_00052.jpg

LM Start	9.33	Rating **	M	Issue No.	73
LM End	9.33	Issue Type +	En	Location *	LS
Category	Earthen Levee			GPS Latitude/Longitude	
				Start	End
Item	Encroachments			38.145957 °	38.145957 °
				-121.589653 °	-121.589653 °
DWR ID	DWR_RD0563_01_s_2012_73				
Comment Code					
PR : Prunings					
Inspector Comment					
Large pruning pile on landside toe.

Looking east at large pruning piles at landward toe. (Spring 2017)

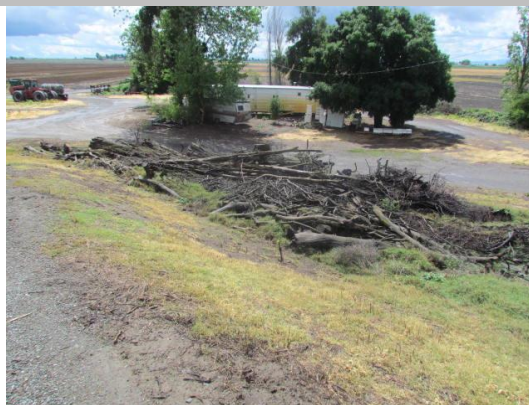
Photo 2 of 3 : SP_2018_RD0563_210_73_20180305_00053.jpg

Looking east at prunings at landward toe. (Spring 2015)

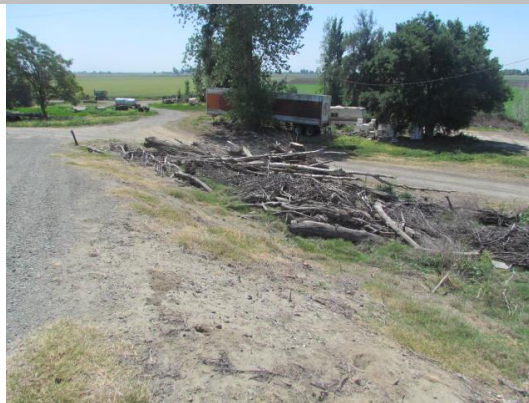
Photo 3 of 3 : SP_2018_RD0563_210_73_20180305_00054.jpg

Looking east at prunings on landward slope. (Spring 2013)

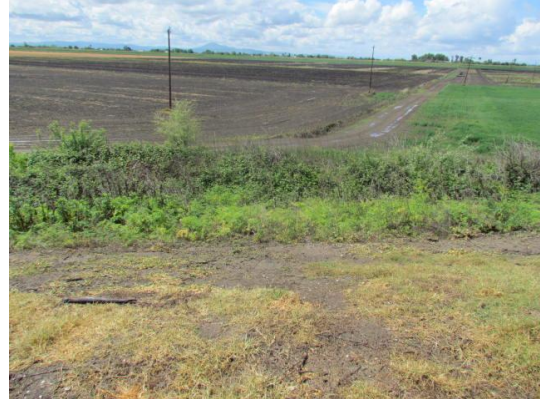
Photo 1 of 1 : SP_2018_RD0563_210_769_20180305_00143.jpg

LM Start	9.36	Rating **	M	Issue No.	769
LM End	9.43	Issue Type +	Ma	Location *	LS
Category	Earthen Levee			GPS Latitude/Longitude	
				Start	End
Item	Vegetation			38.146276 °	38.147034 °
				-121.590189 °	-121.590907 °
DWR ID	DWR_RD0563_01_s_2015_769				
Comment Code					
V2 : Remove the wild growth other than native grasses from the levee slopes.					
Inspector Comment

Looking east at dense vegetation at landward toe. (Spring 2015)

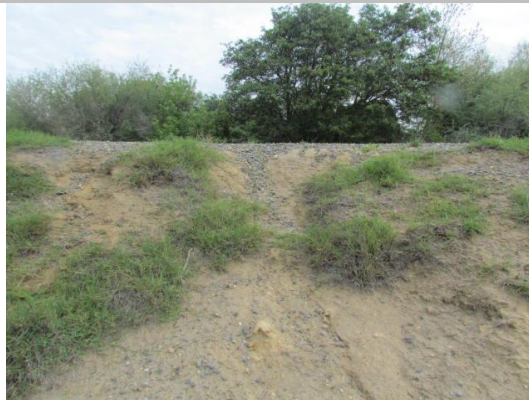
Photo 1 of 2 : SP_2018_RD0563_210_99_20180305_00084.jpg

LM Start	9.65	Rating **	M	Issue No.	99
LM End	9.65	Issue Type +	Ma	Location *	LS
Category	Earthen Levee			GPS Latitude/Longitude	
				Start	End
Item	Erosion / Bank Caving			38.149905 °	38.149905 °
				-121.592910 °	-121.592910 °
DWR ID	DWR_RD0563_01_s_2013_99				
Comment Code					
E1 : Note and monitor erosion site.					
Inspector Comment					
Finger erosion on landside shoulder and slope.

Looking west at minor erosion on landward shoulder and slope.

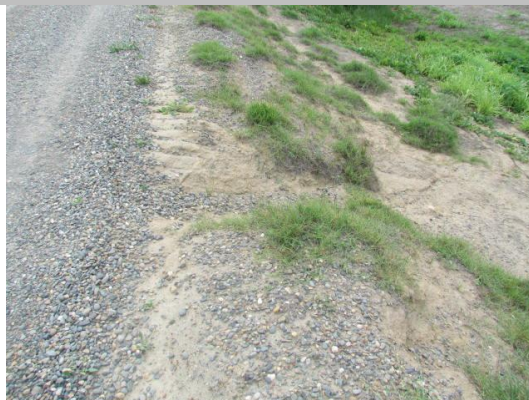
Photo 2 of 2 : SP_2018_RD0563_210_99_20180305_00085.jpg

Looking north at minor erosion on landward shoulder and slope.

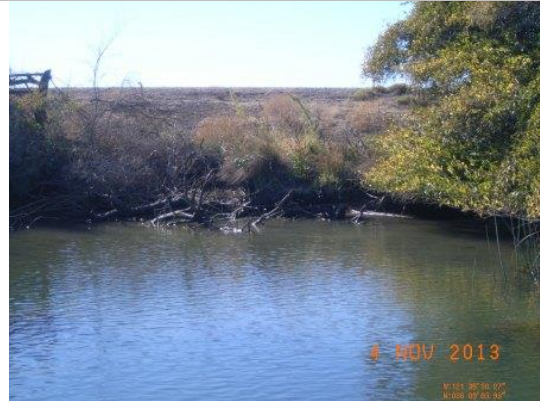
Photo 1 of 1 : SP_2018_RD0563_210_41_20180305_00029.jpg

LM Start	9.73	Rating **	A/W	Issue No.	41
LM End	9.90	Issue Type +	Ma	Location *	WS
Category	Supplemental			GPS Latitude/Longitude	
				Start	End
Item	2015 USACE Erosion Survey, DRAFT			38.150820 °	38.150647 °
				-121.593650 °	-121.596858 °
DWR ID	DWR_RD0563_01_s_2016_41				
Comment Code					
Inspector Comment					
1997 - Erosion pockets into the toe of the levee. 2001 - Staked low fascine walls at the bankline. 2004 - Numerous "Brush Boxes." 2005 - Some new bundles in the brush boxes. 2012 - Site extended downstream to account for new bank sloughing. 2013 - Some rock added to the upstream end by the local RD. 2015: Last observed in 2013. [2015 Site ID: GEO_2-5_L]

USACE 2013 Photo #1

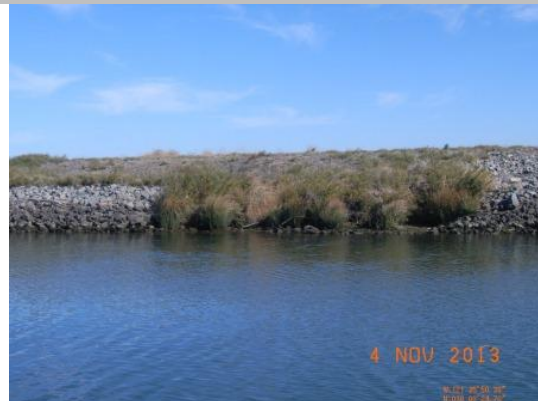
Photo 1 of 1 : SP_2018_RD0563_210_43_20180305_00031.jpg

LM Start	10.45	Rating **	M	Issue No.	43
LM End	10.74	Issue Type +	Ma	Location *	WS
Category	Supplemental			GPS Latitude/Longitude	
				Start	End
Item	2015 USACE Erosion Survey, DRAFT			38.143519 °	38.139918 °
				-121.599677 °	-121.596986 °
DWR ID	DWR_RD0563_01_s_2016_43				
Comment Code					
Inspector Comment					
1997 - Old damaged rock riprap along the toe. 1999 - Downstream end (400 ft) repaired with rock. 2002 - New rock/concrete rubble section on the downstream end. 2004 - Small pocket repairs at the downstream end. 2005 - Some new bundles in the brush boxes. 2012 - Some rock has been placed in last year. 2015: Last observed in 2013. [2015 Site ID: GEO_1-7_L]

USACE 2013 Photo #1

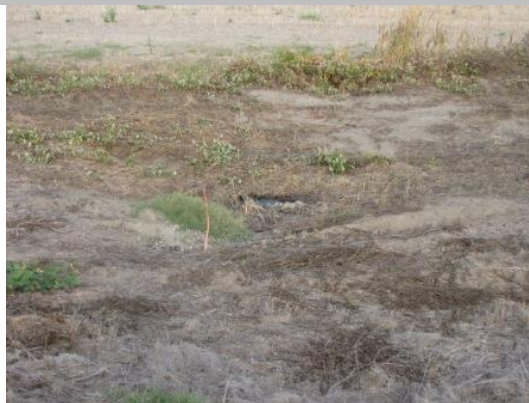
Photo 2 of 4 : SP_2018_RD0563_210_76_20180305_00062.jpg

LM Start	10.59	Rating **	M	Issue No.	76
LM End	10.59	Issue Type +	Ma	Location *	LS
Category	Earthen Levee			GPS Latitude/Longitude	
				Start	End
Item	Slope Stability			38.141940 °	38.141940 °
				-121.598033 °	-121.598033 °
DWR ID	DWR_RD0563_01_s_2012_76				
Comment Code					
S1 : Repair slope instability.					
Inspector Comment					
Deep depression on landside shoulder and slope; possible pipe collapse.

Looking east at water ponding at landside toe just above 10" irrigation pipe.

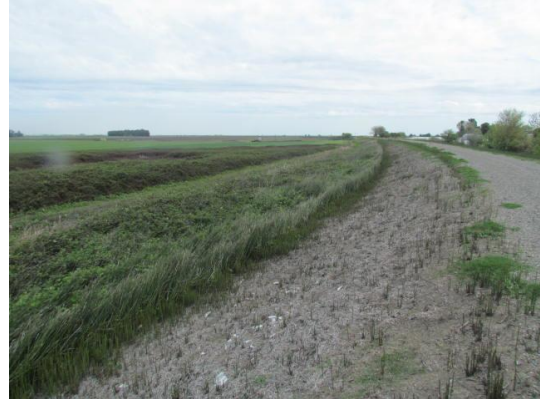
Photo 3 of 3 : SP_2018_RD0563_210_100_20180305_00088.jpg

LM Start	10.67	Rating **	U	Issue No.	100 (cont)	
LM End	10.81	Issue Type +	Ma	Location *	LS	
Category	Earthen Levee			GPS Latitude/Longitude		
				Start	End	
Item	Vegetation			38.140886 °	38.139079 °	
				-121.597280 °	-121.596214 °	
DWR ID	DWR_RD0563_01_s_2013_100					
Comment Code						
V2 : Remove the wild growth other than native grasses from the levee slopes.						
Inspector Comment						
Wild rose or grape vines on landside slope and toe.

Looking south at additional dense vegetation at landward toe.

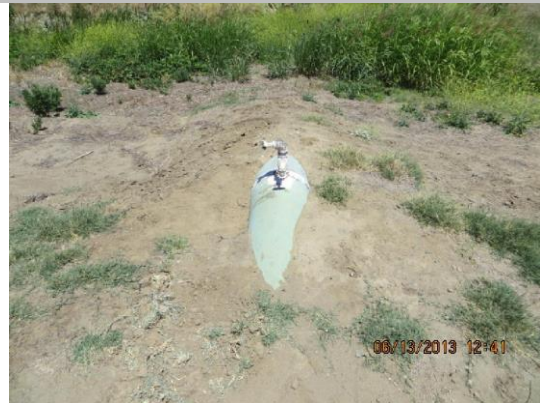
Photo 1 of 3 : UCIP_SP_2018_15002_24691.jpg

Comment Code					
Inspector Comment					
FS_ID:15002 DS_ID:20170 EP_NO: 11217 Repair Type: Non-Urgent Crossing Status: Found UCIP Comments: Pipe does not have appropriate clearance at Levee crown. FIELD_STRUCT_DESC: 9 of 11: 16-inch steel irrigation siphon pipe through the levee, 1 foot below the crown. Air vent/filler pipe on the landside (LS) shoulder. Slide gate in a 5-foot-diameter steel standpipe on the LS toe. (Automatic Board Order (ABO) issued as Permit No. 11217, 1975 - Owen E. Wilkenson). [Additional Reference(s): DWR Levee Log, 2005. USACE Sacramento O&M Manual 103, June 1954, (Station ""L "" 60+34) (14-inch pipe listed)]. FS Date: 6/13/2013

Vent/filler on pipe at LS shoulder.

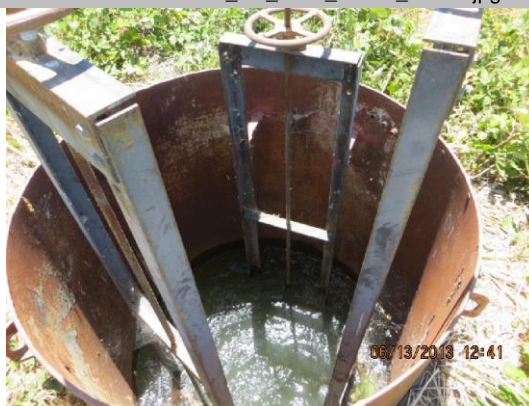
Photo 2 of 3 : UCIP_SP_2018_15002_24690.jpg

Item	DWR UCIP Field Study			38.136937 °	38.136937 °	
				-121.594521 °	-121.594521 °	
DWR ID						
Comment Code						
Inspector Comment						
FS_ID:15002 DS_ID:20170 EP_NO: 11217 Repair Type: Non-Urgent Crossing Status: Found UCIP Comments: Pipe does not have appropriate clearance at Levee crown. FIELD_STRUCT_DESC: 9 of 11: 16-inch steel irrigation siphon pipe through the levee, 1 foot below the crown. Air vent/filler pipe on the landside (LS) shoulder. Slide gate in a 5-foot-diameter steel standpipe on the LS toe. (Automatic Board Order (ABO) issued as Permit No. 11217, 1975 - Owen E. Wilkenson). [Additional Reference(s): DWR Levee Log, 2005. USACE Sacramento O&M Manual 103, June 1954, (Station ""L "" 60+34) (14-inch pipe listed)]. FS Date: 6/13/2013

slide gate in steel riser on LS toe.

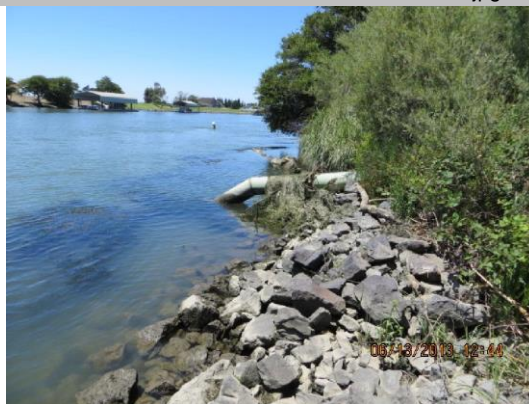
Photo 3 of 3 : UCIP_SP_2018_15002_24689.jpg

Pipe visible on WS toe.

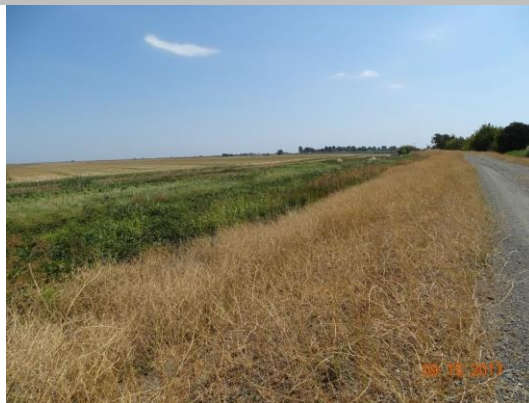
Photo 1 of 3 : SP_2018_RD0563_210_770_20180305_00144.jpg

LM Start	11.01	Rating **	U	Issue No.	770
LM End	12.00	Issue Type +	Ma	Location *	LS
Category	Earthen Levee			GPS Latitude/Longitude	
				Start	End
Item	Vegetation			38.136623 °	38.130739 °
				-121.594216 °	-121.579678 °
DWR ID	DWR_RD0563_01_s_2015_770				
Comment Code					
V2 : Remove the wild growth other than native grasses from the levee slopes.					
Inspector Comment					
Dense veg (wildroses) at landside toe.

Looking southeast at the landside slope.

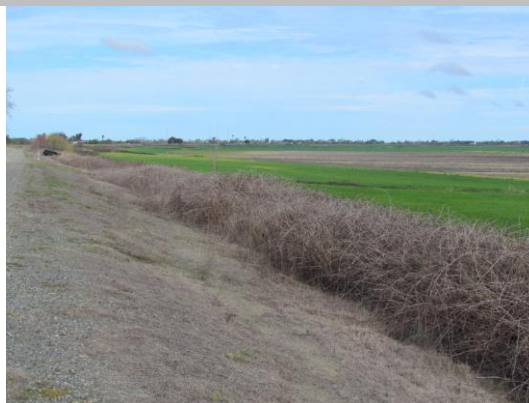
Photo 2 of 3 : SP_2018_RD0563_210_770_20180305_00145.jpg

Looking northeast at dead vines at landward toe. (Spring 2017)

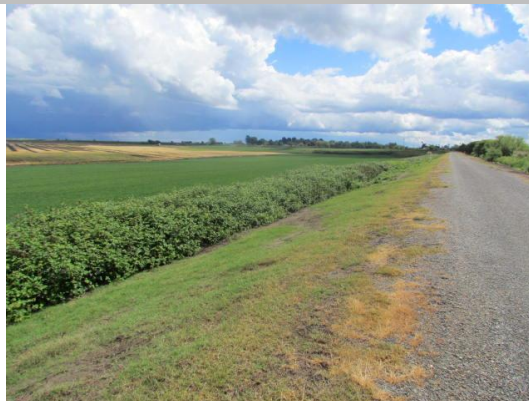
Photo 3 of 3 : SP_2018_RD0563_210_770_20180305_00146.jpg

Looking southeast at dense vegetation at landward toe. (Spring 2015)

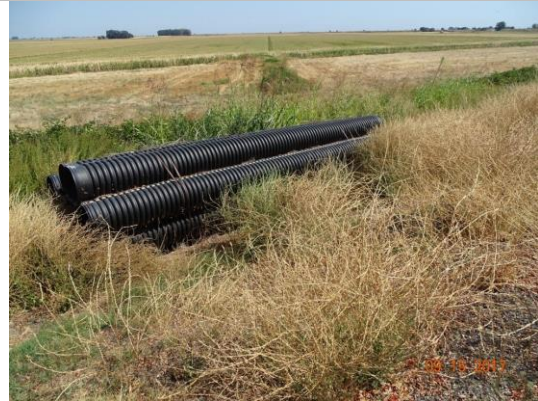
Photo 1 of 1 : SP_2018_RD0563_210_118_20180305_00098.jpg

LM Start	11.25	Rating **	M	Issue No.	118
LM End	11.25	Issue Type +	En	Location *	LS
Category	Earthen Levee			GPS Latitude/Longitude	
				Start	End
Item	Encroachments			38.134149 °	38.134149 °
				-121.591281 °	-121.591281 °
DWR ID	DWR_RD0563_01_f_2017_118				
Comment Code					
EQ : Equipment					
Inspector Comment					
Pipe bundles stored on landside slope.

Looking east at the landside slope.

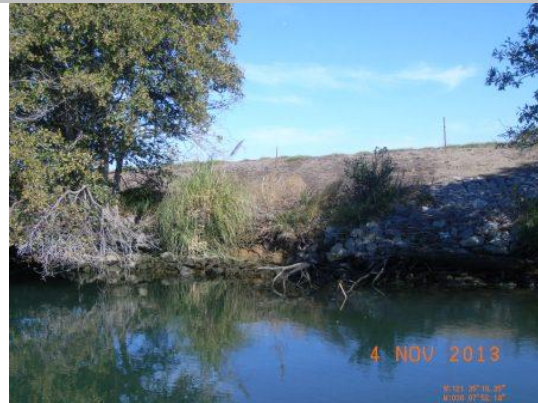
Photo 1 of 1 : SP_2018_RD0563_210_42_20180305_00030.jpg

Comment Code					
Inspector Comment					
1997 - Erosion pockets into the levee toe. 1999 - Some small pockets fixed with rock riprap. 2002 - New "brush boxes" along the bank toe. 2005 - Brush boxes are empty. Some pockets are filled with new stone. 2006 - Some new rock at the downstream end (~100 ft long). Several small pockets of new rock in scallops. Brush boxes in poor to fair condition. 2010 - Site looks a little worse, some toe rock but still has erosion scars at lower to mid slope. 2011 - Site upgraded to CRITICAL. Significant new erosion. Erosion scallops are vertical and almost the height of the levee. 2012 - Rock has been placed in some of the erosion scallops and therefore the site is no longer critical. 2013 - Site shortened site. The downstream half of site was repaired by RD. Pipe no longer in site limits. 2015: Last observed in 2013. [2015 Site ID: GEO_0-3_L]

USACE 2013 Photo #1

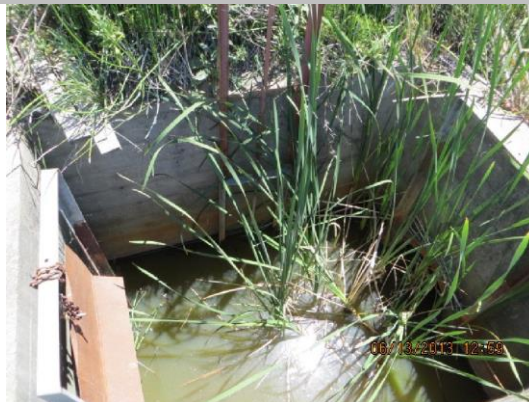
Photo 2 of 3 : UCIP_SP_2018_15004_24704.jpg

LM Start	11.76	Rating **	M	Issue No.	803
LM End	11.76	Issue Type +	En	Location *	
Category	Supplemental			GPS Latitude/Longitude	
				Start	End
Item	DWR UCIP Field Study			38.130291 °	38.130291 °
				-121.583981 °	-121.583981 °
DWR ID					
Comment Code					
Inspector Comment					
FS_ID:15004 DS_ID:20174 EP_NO: 11217 Repair Type: Non-Urgent Crossing Status: Found UCIP Comments: Pipe appears abandoned and should be done so properly. FIELD_STRUCT_DESC: 11 of 11: 12-inch steel irrigation siphon pipe through the levee, 4.5 feet below the crown. Air vent on the landside (LS) shoulder, and slide gate in a 7-foot by 9-foot concrete distribution box at the LS toe. (Automatic Board Order (ABO) issued as Permit No. 11217, 1975 - Owen E. Wilkenson). [Additional Reference(s): DWR Levee Log, 1980. USACE Sacramento O&M Manual 103, June 1954, (Station ""L "" 19+23.5)]. FS Date: 6/13/2013

Distribution box and slide gate visible on LS toe.

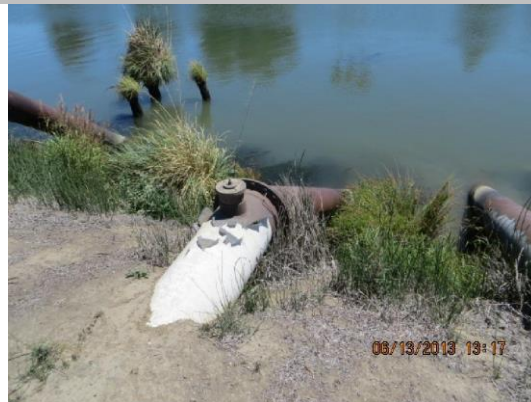
Photo 3 of 3 : UCIP_SP_2018_15027_24729.jpg

LM Start	12.00	Rating **	A/W	Issue No.	804 (cont)	
LM End	12.00	Issue Type +	Ma	Location *		
Category	Supplemental			GPS Latitude/Longitude		
				Start		End
Item	DWR UCIP LMA Responsibility			38.130726 °	38.130726 °	
				-121.579646 °	-121.579646 °	
DWR ID						
Comment Code						
Inspector Comment						
FS_ID:15027 DS_ID:20172 EP_NO: 11213 Repair Type: No Action Needed Crossing Status: Found UCIP Comments: FIELD_STRUCT_DESC: 20-inch steel drainage pipe through the levee, 1 foot below the crown. Pump on the landside (LS). Siphon breaker on the waterside (WS) shoulder. (18-inch pipe [HLM 12.28] at a depth of 4-feet authorized under Automatic Board Order (ABO) issued as Permit No. 11213, 1975 - Reclamation District No. 563). [Additional Reference(s): DWR Levee Log, 2005. USACE Sacramento O&M Manual 103, June 1954, (Station ""L "" 6+48.9)]. FS Date: 6/13/2013

Pipe and siphon breaker on WS shoulder.

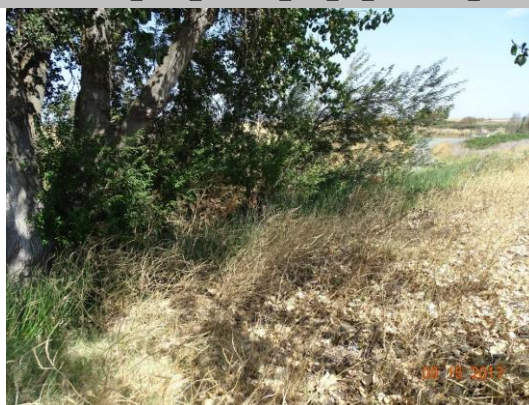
Photo 1 of 2 : SP_2018_RD0563_210_47_20180305_00035.jpg

LM Start	12.04	Rating **	M	Issue No.	47
LM End	12.04	Issue Type +	Ma	Location *	LS
Category	Earthen Levee			GPS Latitude/Longitude	
				Start	End
Item	Trim / Thin Trees			38.130758 °	38.130758 °
				-121.579027 °	-121.579027 °
DWR ID	DWR_RD0563_01_s_2012_47				
Comment Code					
T1 : Trim trees to at least five feet above ground level.					
Inspector Comment					
Trim tree on landside slope.

Looking northeast at the landside slope.
